DEPARTMENT OF TRANSPORTATION

Contract #: 04-0120F4Cty: SF/ALA Rte: 80 PM: 13.2/13.9File #: 69.28**WELDING INSPECTION REPORT****Resident Engineer:** Pursell, Gary**Address:** 333 Burma Road**City:** Oakland, CA 94607**Report No:** WIR-015516**Date Inspected:** 11-Jul-2010**Project Name:** SAS Superstructure**OSM Arrival Time:** 700**Prime Contractor:** American Bridge/Fluor Enterprises, a JV**OSM Departure Time:** 1900**Contractor:** Zhenhua Port Machinery Company, Ltd (ZPMC), Changxing Island **Location:** Shanghai, China**CWI Name:** Li Yang**CWI Present:** Yes No**Inspected CWI report:** Yes No N/A**Rod Oven in Use:** Yes No N/A**Electrode to specification:** Yes No N/A**Weld Procedures Followed:** Yes No N/A**Qualified Welders:** Yes No N/A**Verified Joint Fit-up:** Yes No N/A**Approved Drawings:** Yes No N/A**Approved WPS:** Yes No N/A**Delayed / Cancelled:** Yes No N/A**Bridge No:** 34-0006**Component:** OBG**Summary of Items Observed:**

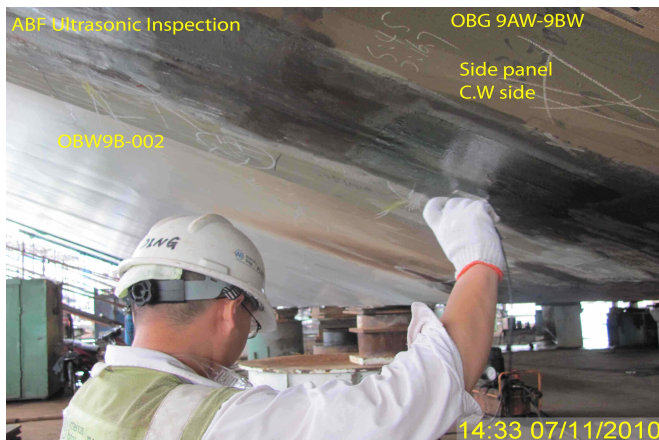
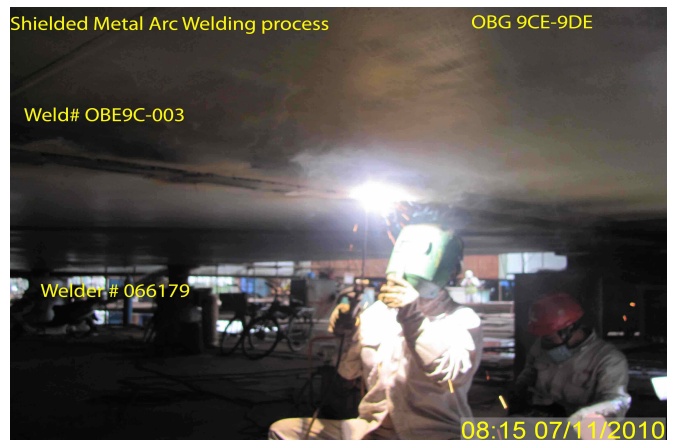
This Quality Assurance (QA) Inspector observed ZPMC qualified welders 037932, 066179 and 067765 performing Shielded Metal Arc Welding process for weld 003 located on PCMK OBE9C. ZPMC QC Mr. Wang Li Yang monitoring this welding. The welding variables recorded by QC appeared to comply with the WPS-B-P-2214-B-U2-FCM-1.

This Quality Assurance (QA) Inspector observed ZPMC qualified welder 048659 performing Shielded Metal Arc Welding process for weld 006 located on PCMK OBE9. ZPMC QC Mr. Li Yang monitoring this welding. The welding variables recorded by QC appeared to comply with the WPS-345-SMAW-3G (3F)-Fcm-Repair-1. Critical weld repair report identified as B-CWR1701.

This Quality Assurance (QA) Inspector observed ABF personnel performing Ultrasonic Inspection for side panel splice weld between OBG segment 9BE and 9CE (cross beam side).

This Quality Assurance (QA) Inspector observed ZPMC personnel performing Ultrasonic Inspection for the weld between cross beam side longitudinal diaphragm web to floor beam at PP76 east side.

This Quality Assurance (QA) Inspector observed ABF personnel performing Magnetic Particle Inspection for the hold back weld between side panels and "T" stiffener in OBG segment 9BW at splice weld between OBG segment 9BW and 9AW (counter weight side).

This Quality Assurance (QA) Inspector observed ABF personnel performing Ultrasonic Inspection for side panel splice weld between OBG segment 9AW and 9BW (counter weight side).
